## Waterford River Watershed Management Plan – Draft Copy

Sabina Akhter, B.Tech, AD Water Quality, Watershed Conservation Coordinator

November 2022

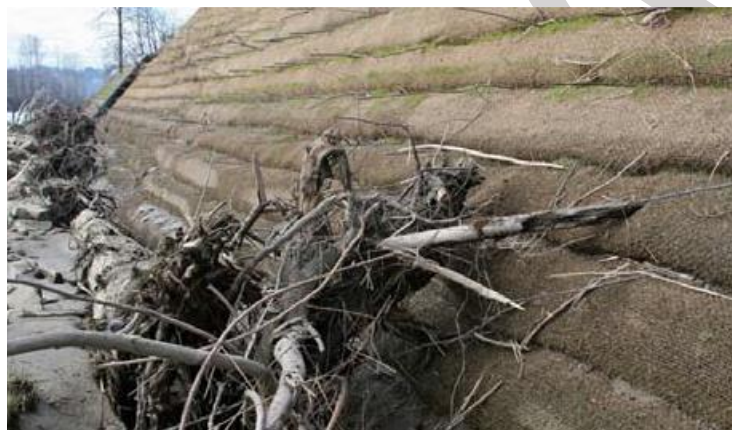
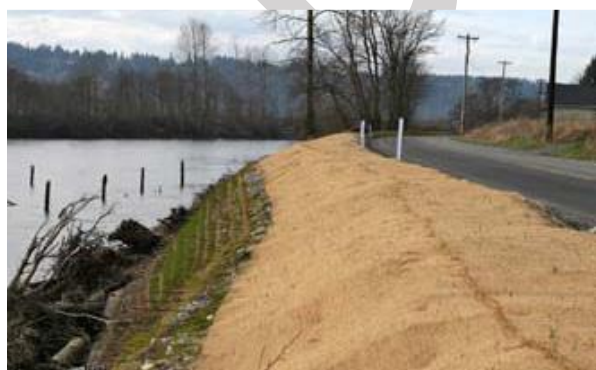
**Figure 9.**

*Structural Earth Wall (SEW).*

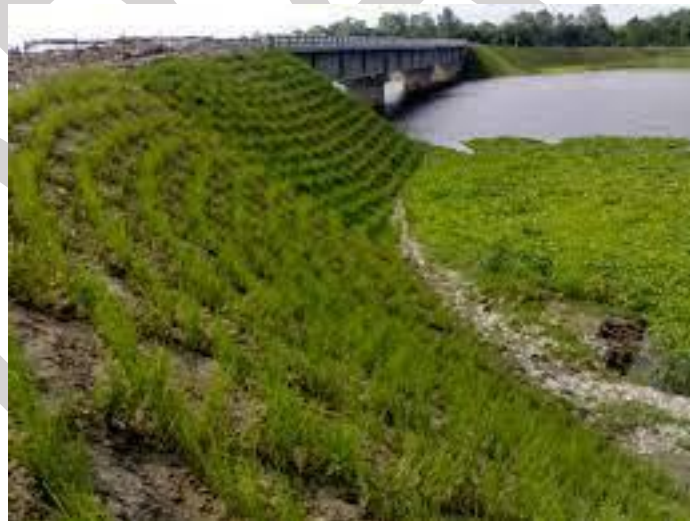
**Figure 11**

*Vegetated road embankment slopes.*

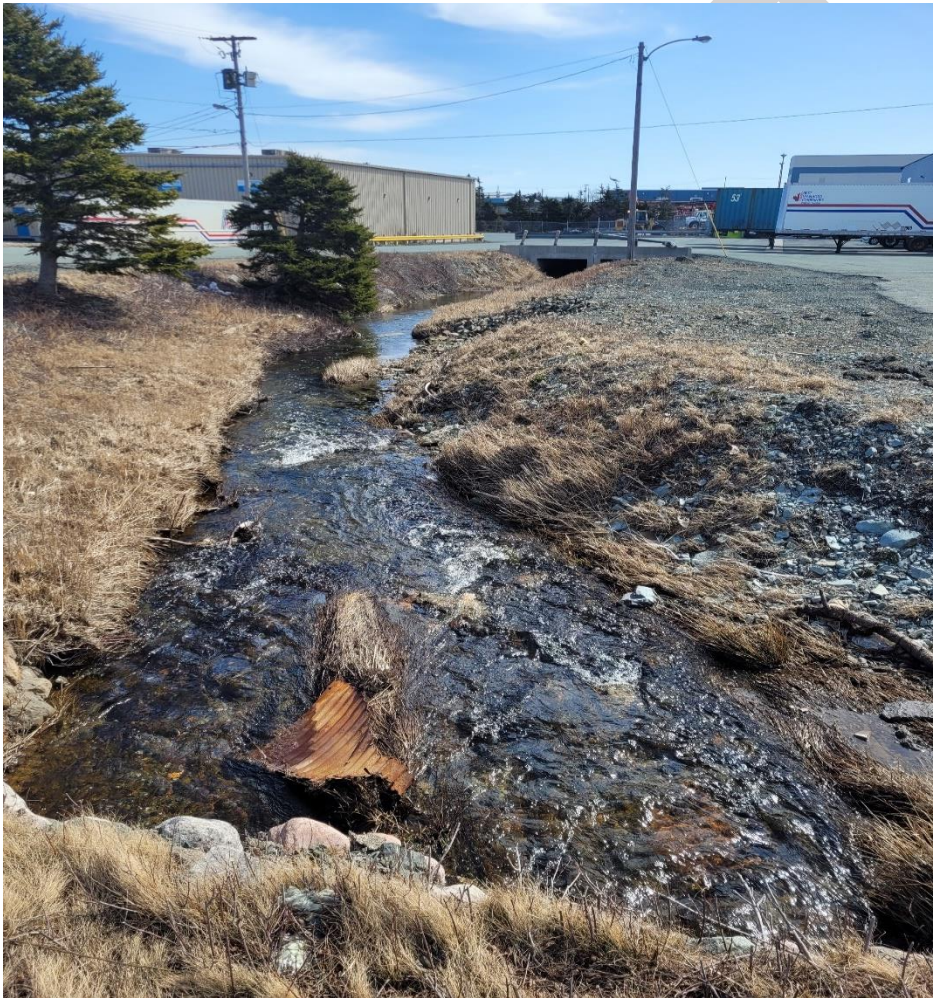
**Figure 15.**

**2. Donovan's Industrial Park:** The Unnamed River known as the Donovan's tributary flows through Donovan's Industrial Park before meeting the Waterford River. The riparian buffer zone conditions in some parts of the river are degraded and the waterbody is highly susceptible to industrial runoff. The river channel is typical of other industrial areas and is channelized. Also, during winter, snowbanks from parking lot snow clearing activities were noticed to be stored very close to the streams. The snowmelt likely carries road salts and gets deposited in the form of runoff to the streams which can have negative impact on the aquatic habitat.

*Section of Donovan's tributary (access from Bruce Street, Mount Pearl).*

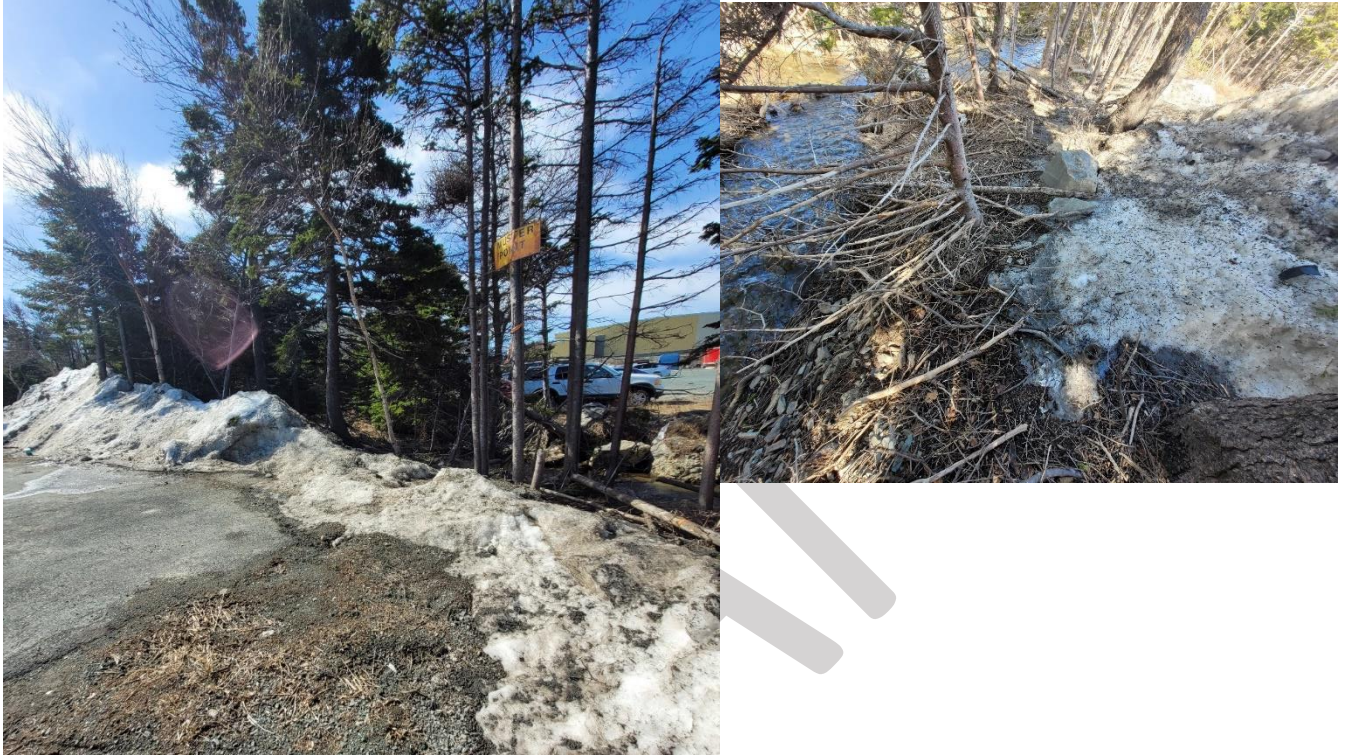
**Figure 16.**

*Snowbank accumulation on the edge of the parking lots in Donovan's Industrial area, Winter 2022.*

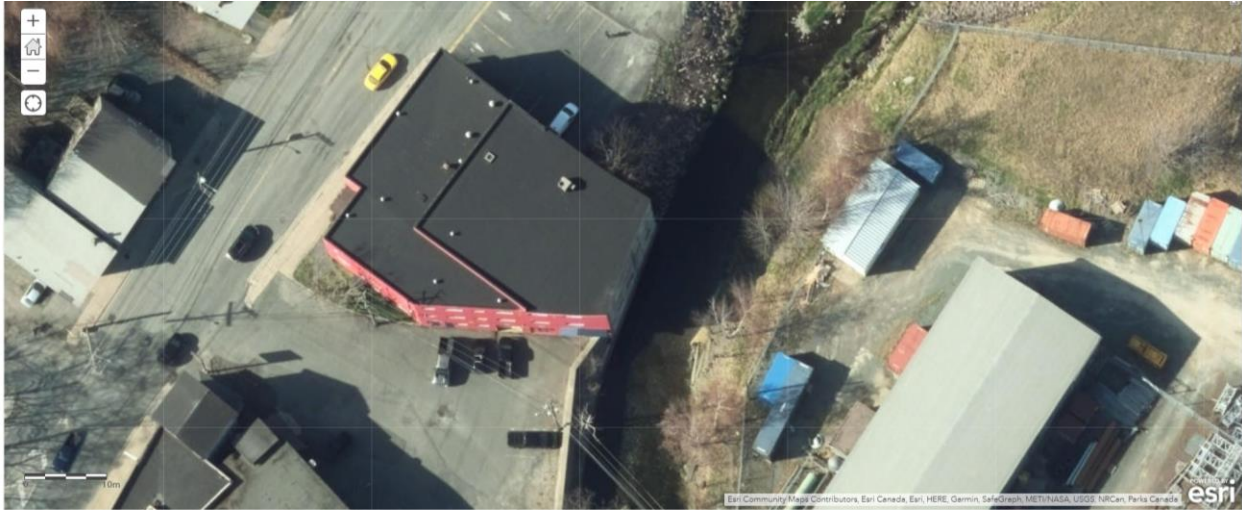
**Figure 19.**

**Properties on the Floodplains:** Some buildings in the Watershed were noticed to be very close to the river's edge leaving no room for any buffer zones. Two such infrastructures in the City of St. John's are highlighted in Figure 18 and 19 below.

*A commercial building in the Water Street leaving no room for buffer zone.*

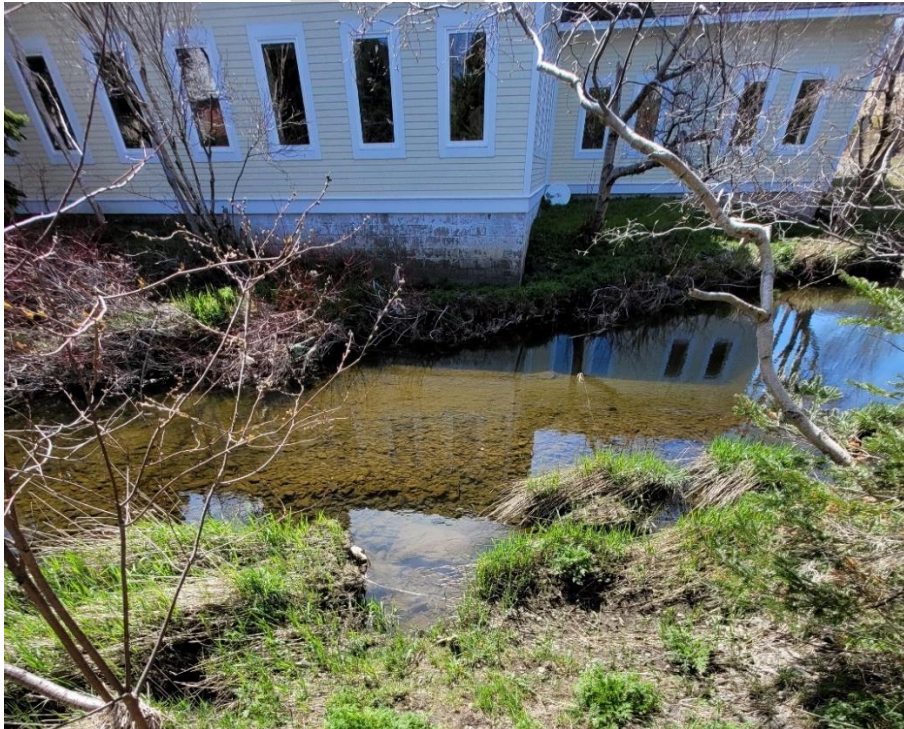
**Figure 20**

*A building in Brookfield Road leaving no room for buffer zone.*

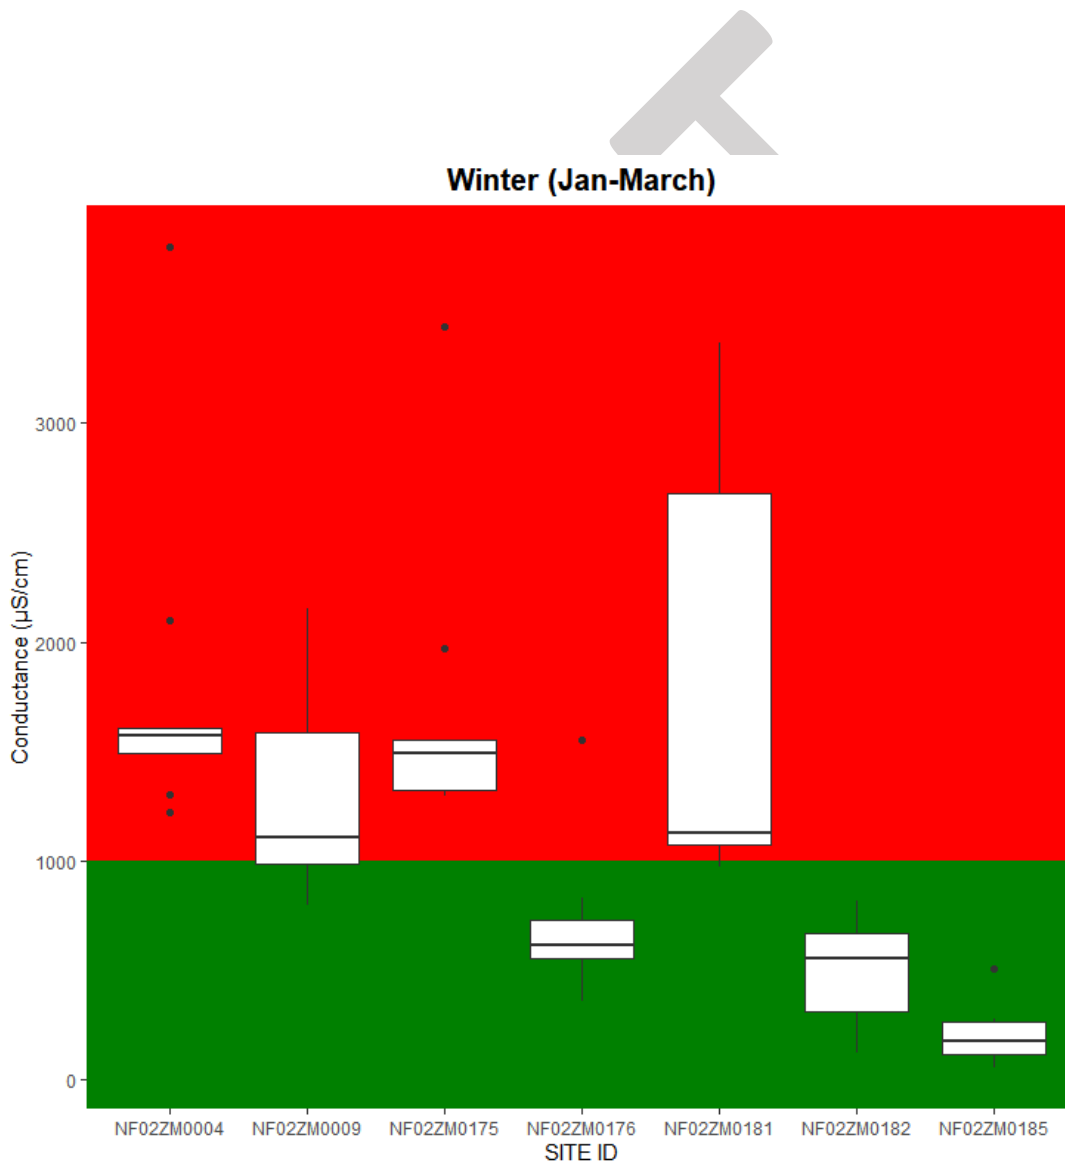
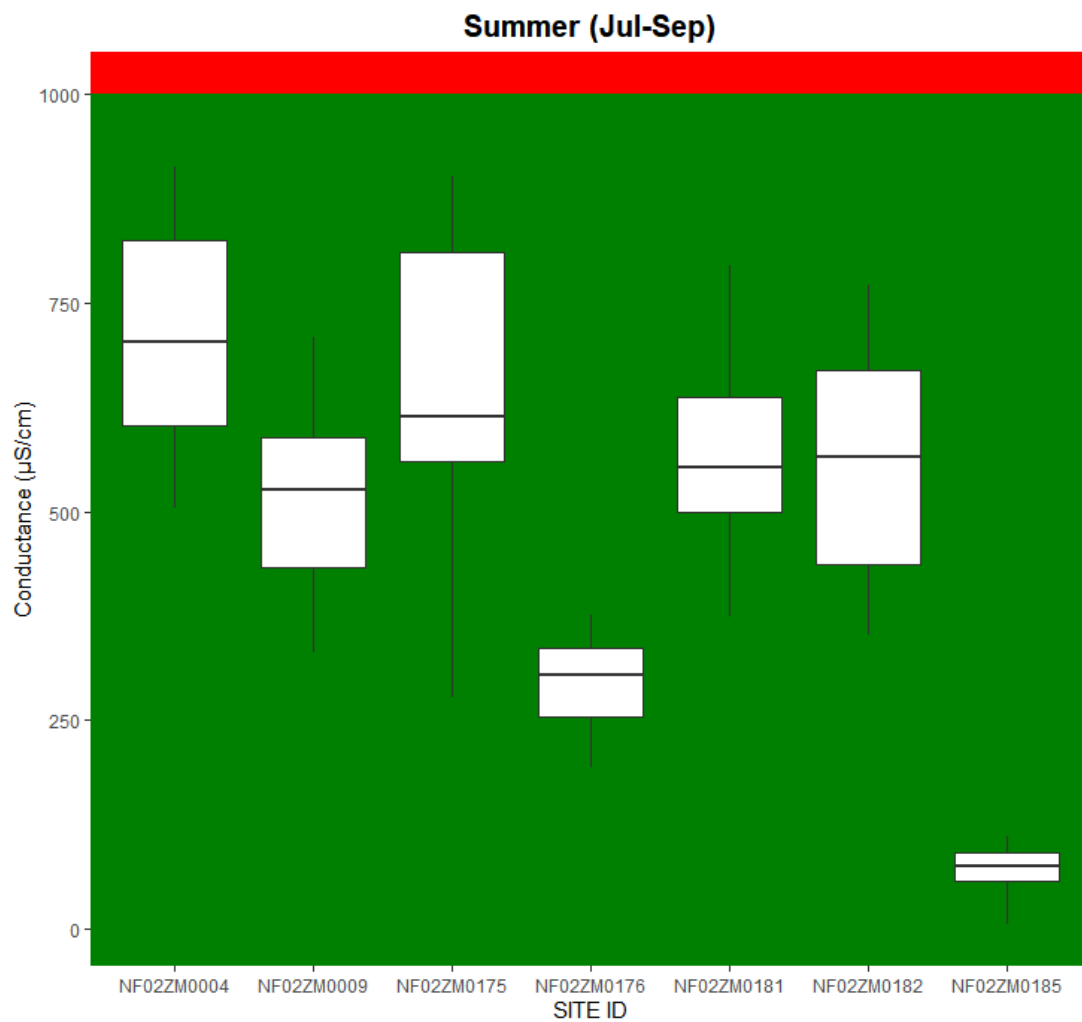
**Conductivity - six grab sample sites and one hydrometric station on the Waterford River (2011-2022)**

*Note.* High conductivity (1000 to 10,000  $\mu\text{S}/\text{cm}$ ) - indicator of saline conditions  
 Source: (DataStream, 2022)

winter months can get deposited in the nearby waterbodies through runoff. The Waterford River Sites at Commonwealth Avenue, Kilbride, Brookfield Road and Blackhead Road exceeded the maximum recommended guideline for conductivity in freshwater and indicated saline conditions. This could be due to road salting operation since the high conductivity was recorded to be high during the winter months.

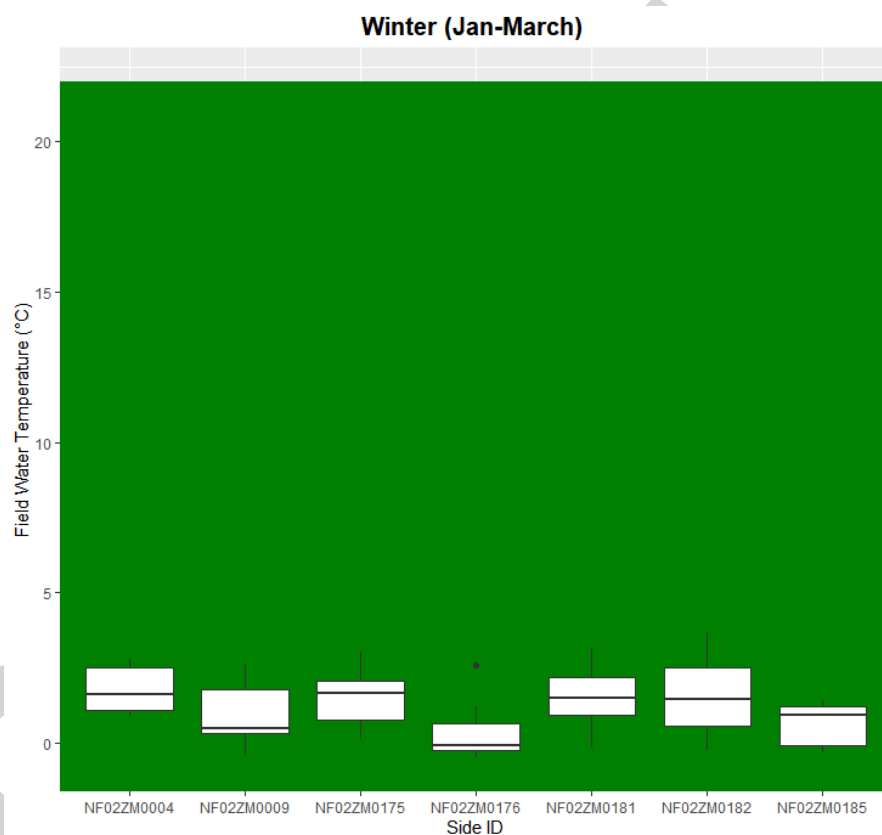
**Temperature - six grab sample sites and one hydrometric station on the Waterford River  
(2011-2022)**

*Note.* Above 22 degrees Celsius - Fish start to show signs of stress.

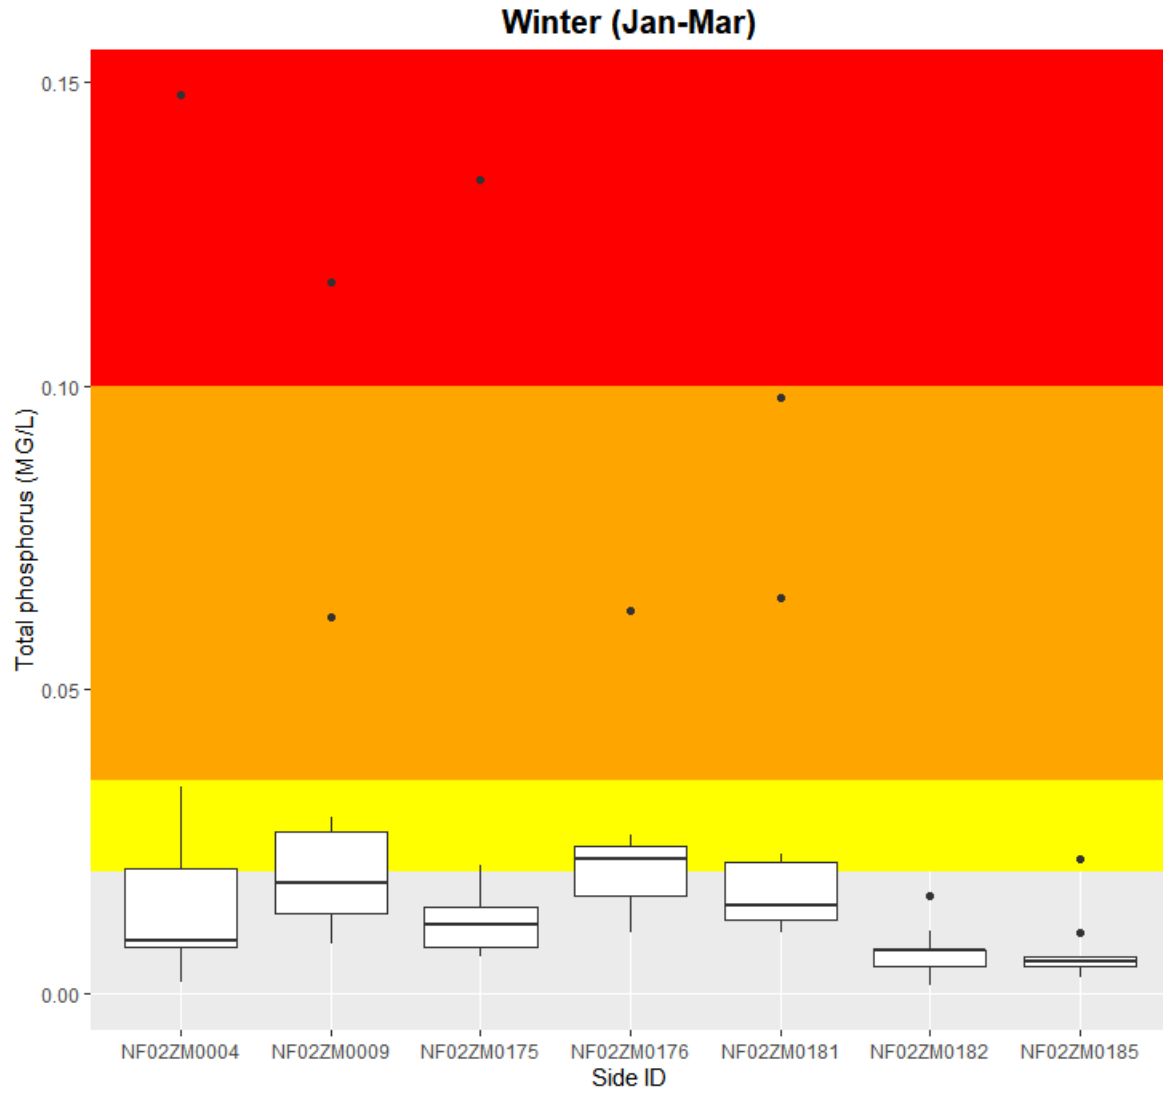
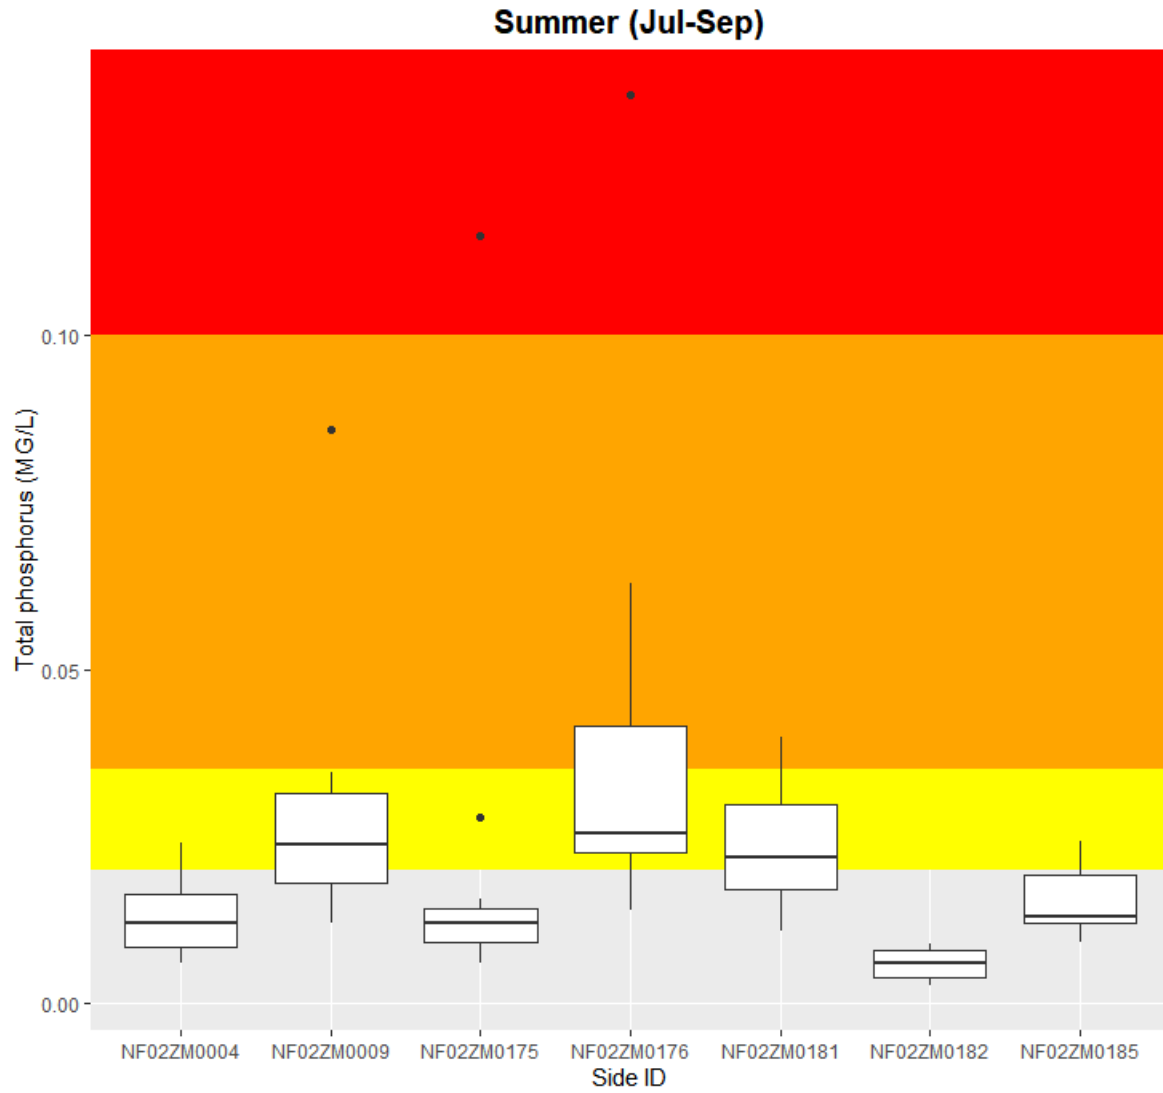
**Phosphorous (Nutrient) - six grab sample sites and one hydrometric station on the Waterford River (2011-2022)**

*Note.* Phosphorous guideline Source: (CCME, 2022)

- Hyper-eutrophic >0.10 mg/l (Indicated in color red)
- Eutrophic, between 0.035 – 0.1 mg/l (Indicated in color orange)
- Meso- eutrophic, between 0.02 – 0.035 mg/l (Indicated in color yellow)

The Canadian Guidance Framework for nutrient includes Total Phosphorus Trigger Ranges to develop guidelines for Phosphorus. It does not provide guidance for other freshwater nutrients. The trigger range for meso-eutrophic, eutrophic and hyper eutrophic conditions in relation to total phosphorus data is considered for this section. Waterford River site in Kilbride and Blackhead Road showed tendency to be meso- eutrophic during the summer months. Runoff input from surrounding urbanized areas such as lawns could have affected the Total phosphorous levels in these sites. The South Brook Site at the mouth closer to the Duck Pond in the Bowring Park fell within the trigger ranges for eutrophic conditions in the summer months. This could be due to the excrements of ducks that inhabit in the area.
